More complicated than it looks

The Sherbourne Resource Centre may look ordinary to the casual observer, but a closer look reveals plenty of engineering challenges requiring thoughtful design. David Brown of the SCI comments on the structural solution.

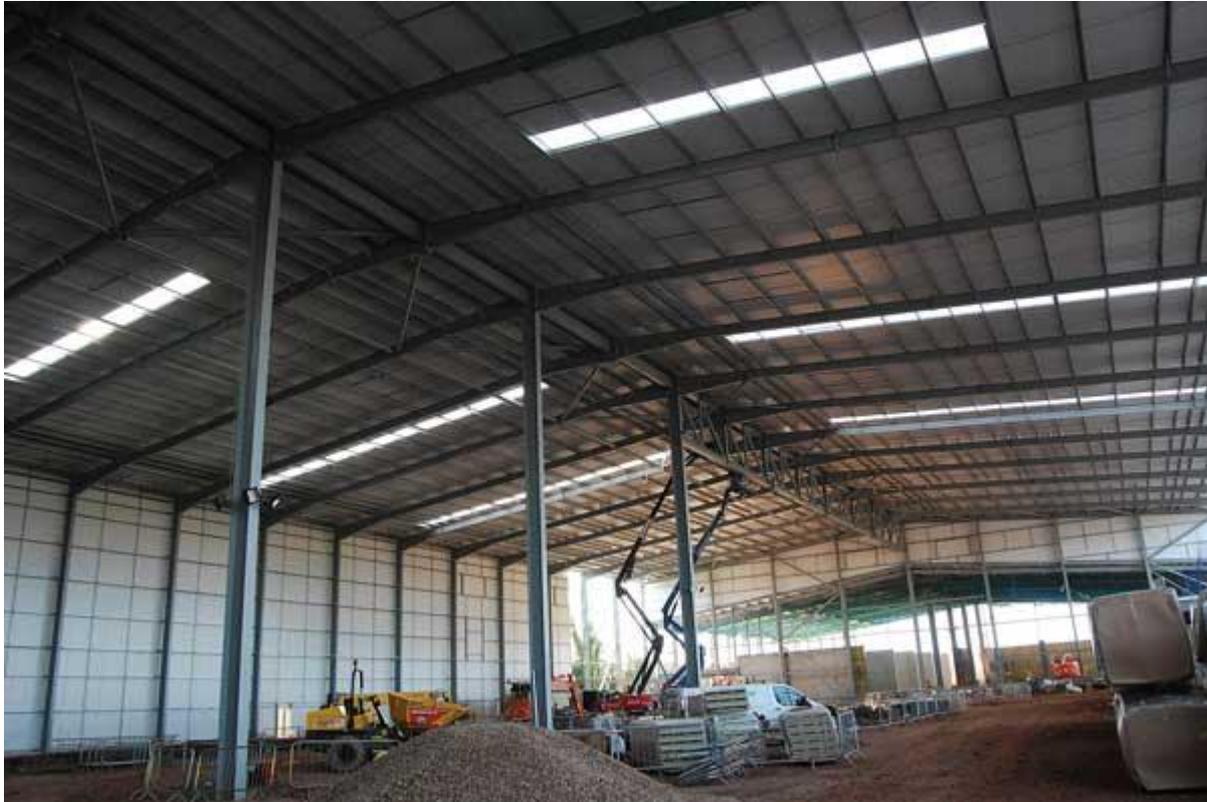
Within the Resource Centre, the Process Hall is 100 m long and initially gives the appearance of a conventional ‘hit and miss’ portal. The columns support the apex, rather than the usual valley arrangement, and have a longitudinal member supporting the apex of the ‘miss’ frames. ‘Hit and miss’ frames always need careful consideration. Firstly, the [transverse stability](#) of the structure is affected due to the different structural arrangement on every other bay. Secondly, the two different frame arrangements would naturally take up a different deflected form, which must be prevented to protect the [cladding](#). The solution adopted at Sherborne was to provide bracing in the plane of the roof between every bay to force the frames to deflect identically. SCI publication P399 includes a procedure for assessing the ‘hit’ and ‘miss’ frames and iteration to determine the lateral forces. A 3d analysis is an alternative approach.

The Resource Centre is however more complicated than an orthodox ‘hit and miss’ frame – at one end of the structure all the ‘miss’ columns are entirely removed and the frames supported on a 52 m-long truss. Under normal loading, the top chord of the truss is in compression and needs lateral restraint – which cannot be provided by the relatively flexible portal frames in the orthogonal direction. The solution here was to provide a [truss](#) in the plane of the roof over the full 100 m length of the building. This lateral truss provides restraint to the 52 m length supporting the portal rafters and provides the essential bracing between the remaining ‘hit and miss’ frames. [Vertical bracing](#) in the gables takes the forces in the lateral truss to ground.

Load reversal due to wind uplift puts the lower chord in compression – restraint is provided by diagonal members from the bottom chord to the portal rafters, which are themselves connected into the lateral truss.

The [portal](#) rafters are continuous through the ‘hit’ apex columns, through the longitudinal apex beam, or through the 52 m-long truss, depending on their location. The 52 m-long truss was detailed with vertical internals on the frame locations, which were [fabricated](#) such that the connection zone was the same as a ‘hit’ column profile, meaning the rafters were identical.

One further challenge was the [erection](#) method for the 52 m-long truss. This was connected on the ground and then held aloft by two cranes whilst certain rafters (and purlins) were erected using a third crane. This temporary case was carefully analysed considering the loading and fixity of the frame at that stage.
